May 20, 1969

SIGNAL DISTORTION ON MODEL 28
AND 35 TELETYPEWRITERS

(Teletypewriter Forces)

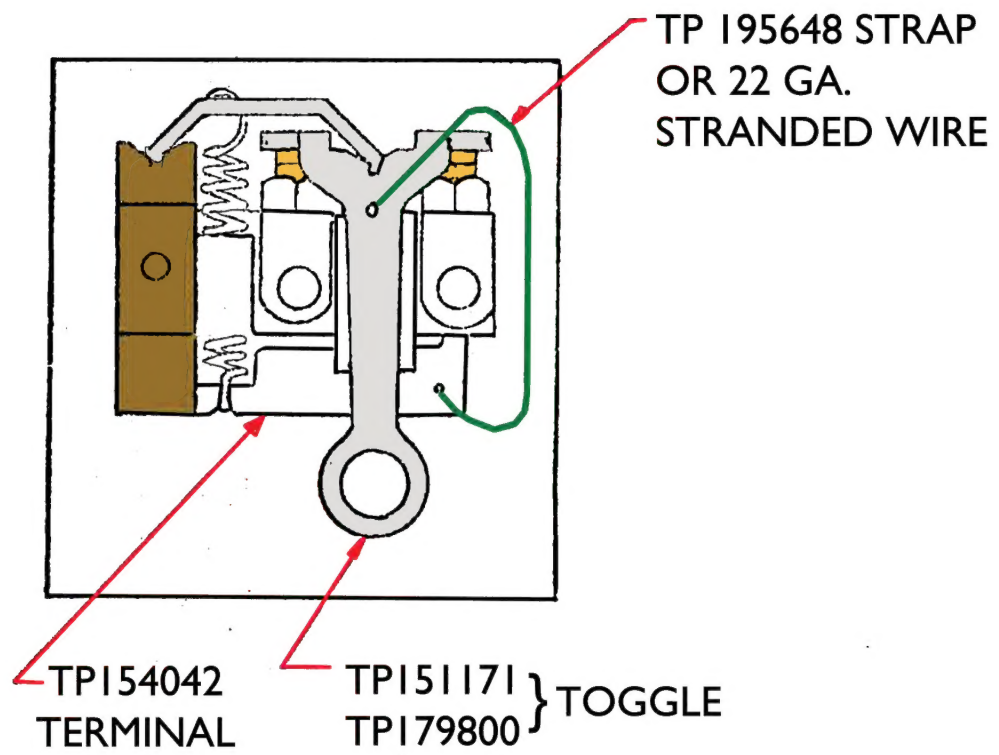
SIGNAL GENERATOR

After a thorough investigation their Laboratory tests revealed the appearance of red rust at the point of the toggle link. This rust creates poor conductivity through the signal generator contacts resulting in peaks up to 45% distortion.

As illustrated in the attachment, using a TP195648 strap or 22 gauge stranded wire, the strapping should be accomplished in the following manner:

- A. For 28 type equipment add strap between the contact toggle (TP151171) and the terminal (TP154042).
- B. For 35 type equipment add strap between the contact toggle (TP179800) and the terminal (TP154042).
